## 2 Type of change

### 0909 Multiple IEC Appliance Outlets F

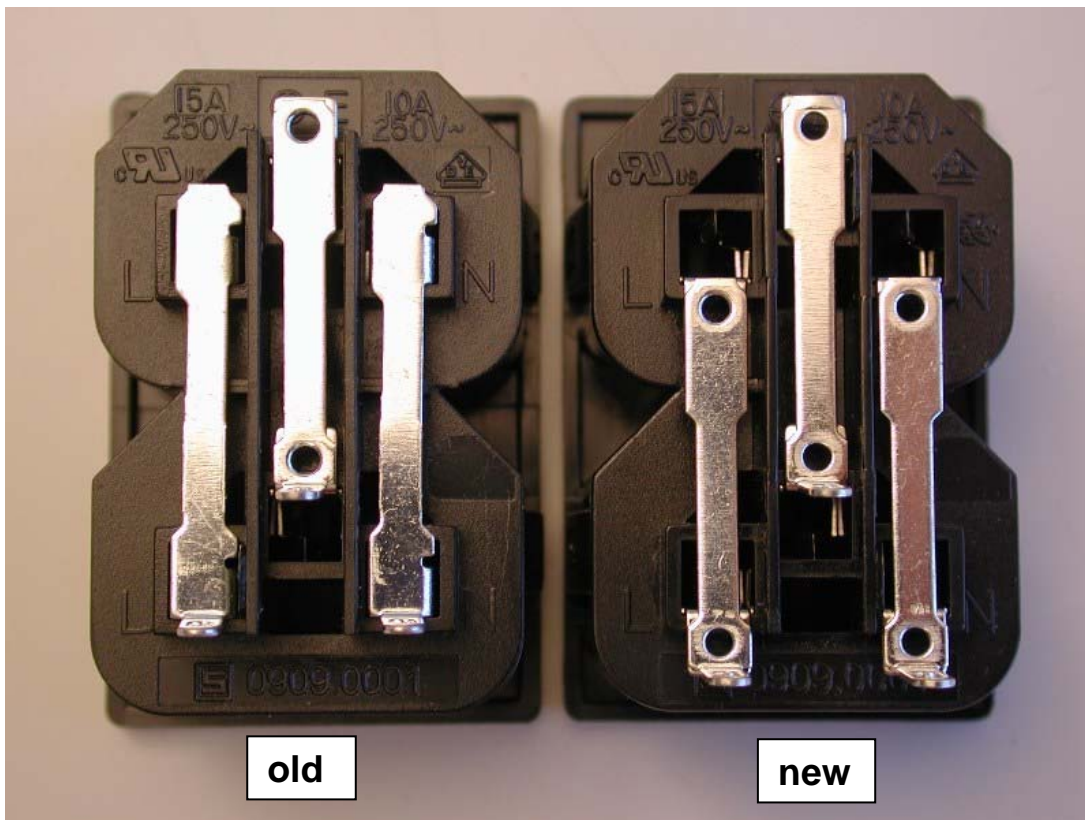
The old version had only the earth bar riveted to the outlet contacts - L/N bars and contacts were made of one piece. The new version has L/N/E riveted. (The holes are the riveting joints)

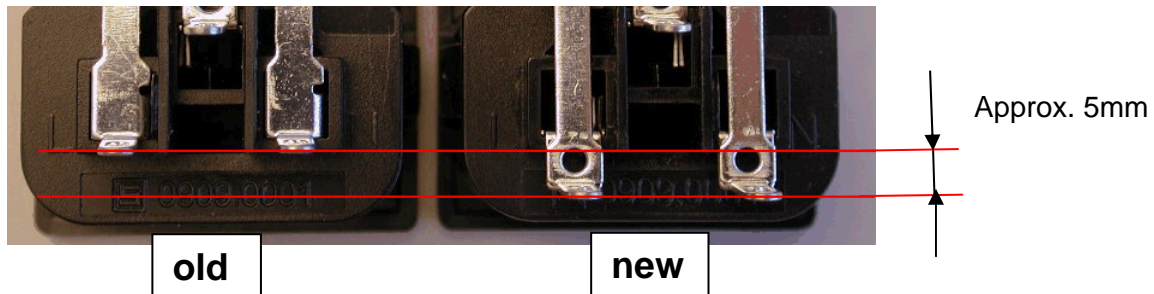
Position of solder terminals of L&N are moved approx 5mm towards the border of the connector.
